Assessment of Dam Safety

Coal Combustion Surface Impoundments (Task 3)

PacifiCorp

Naughton Power Station

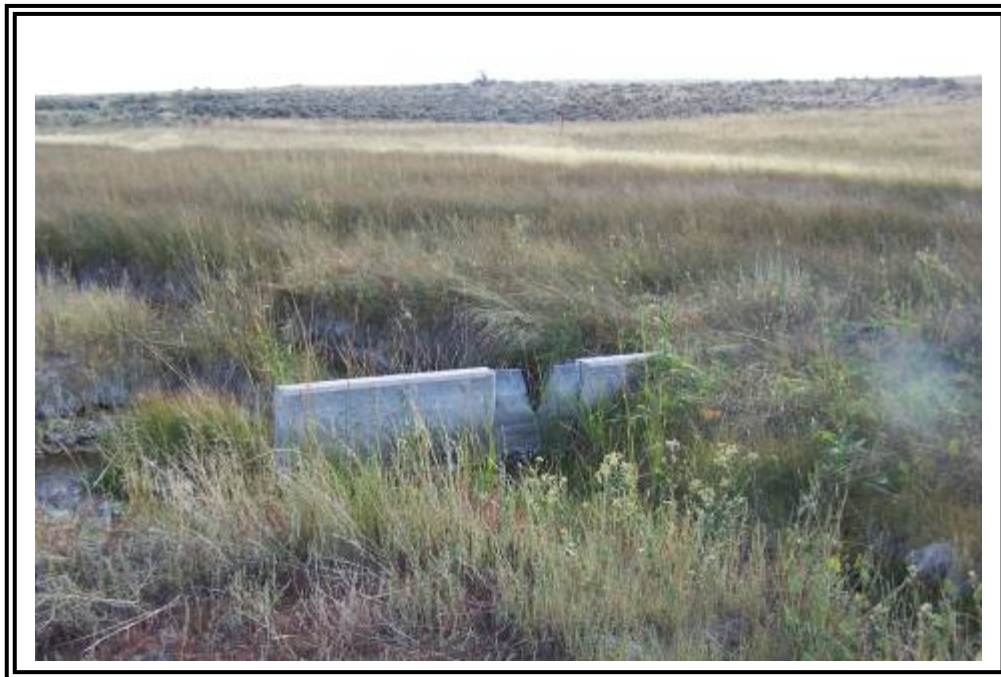
80

Former weir structure along discharge channel beyond the toe of the main dike.
Discharge channel has bypassed the weir structure on the east side.

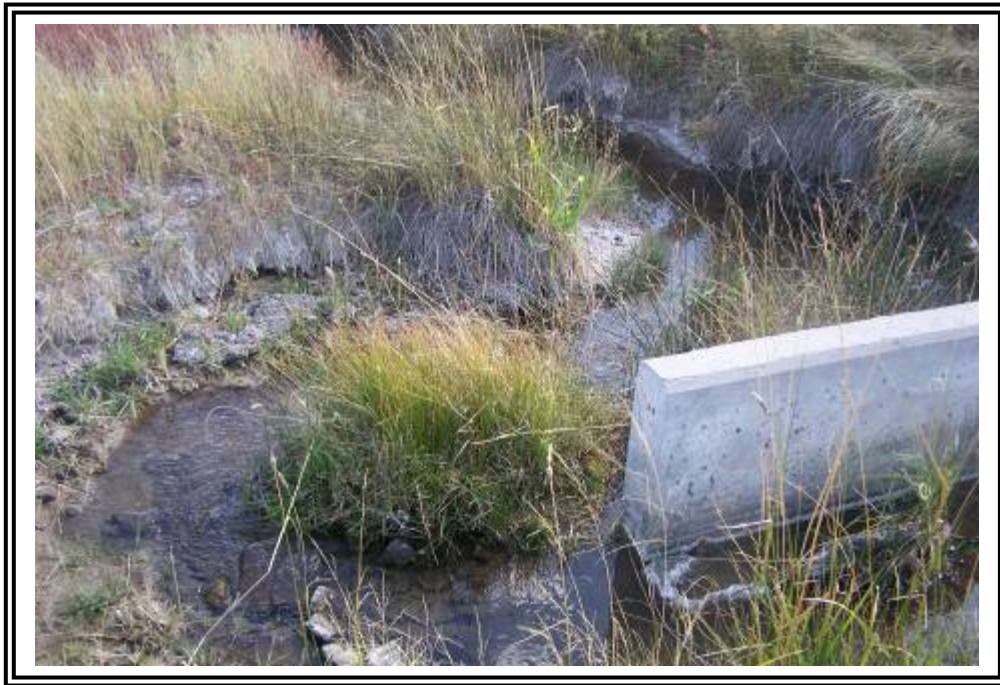
81

Discharge channel bypassing weir structure.

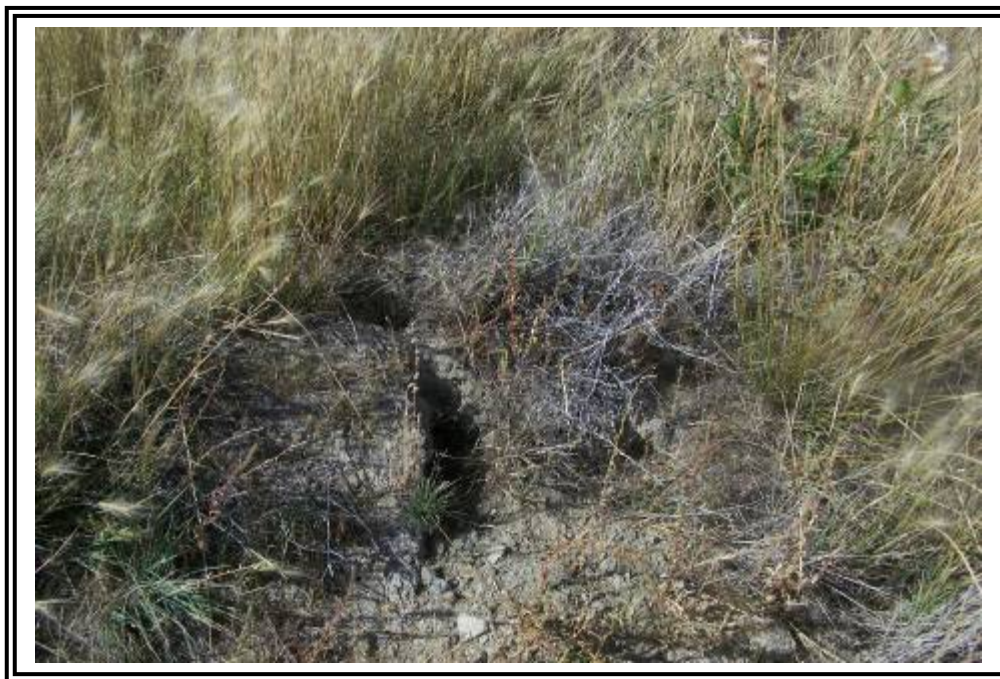
82

Occasional animal burrows on downstream slope of Main Dam.

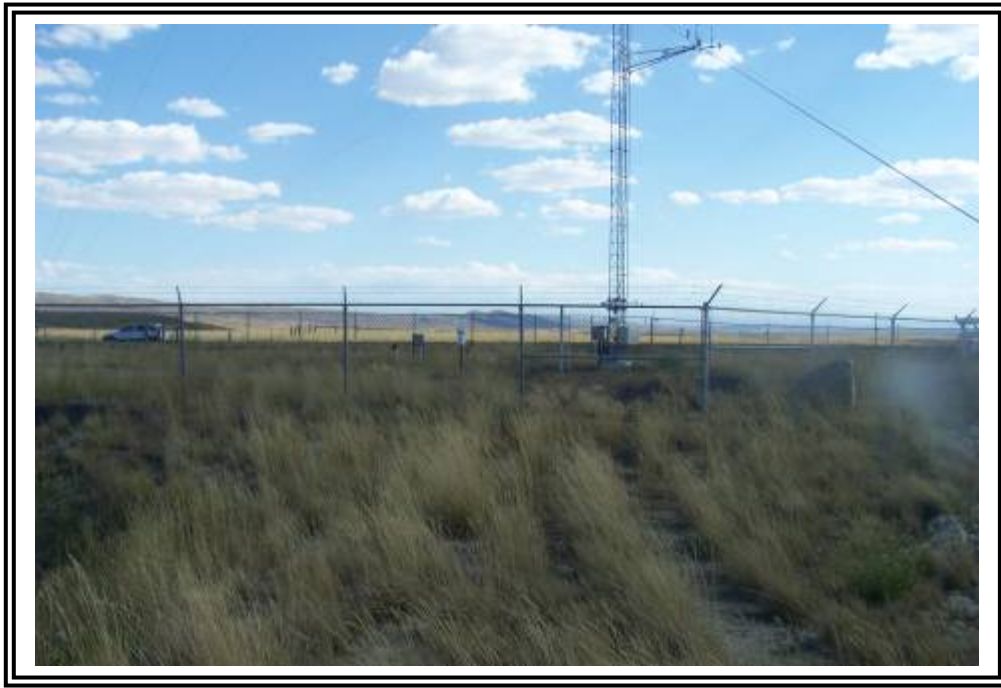
83

South abutment of East Saddle Dike. Note guy wire at right of photo is anchored in the dike.

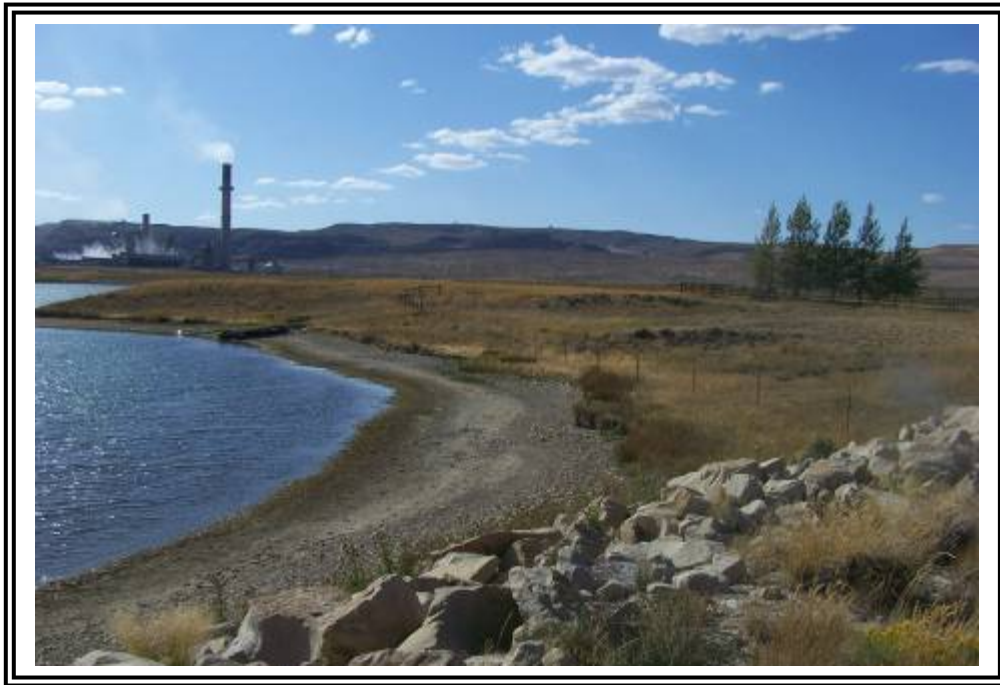
89

Clear water pond is not submerging the north end of the East Saddle Dike at normal pool.

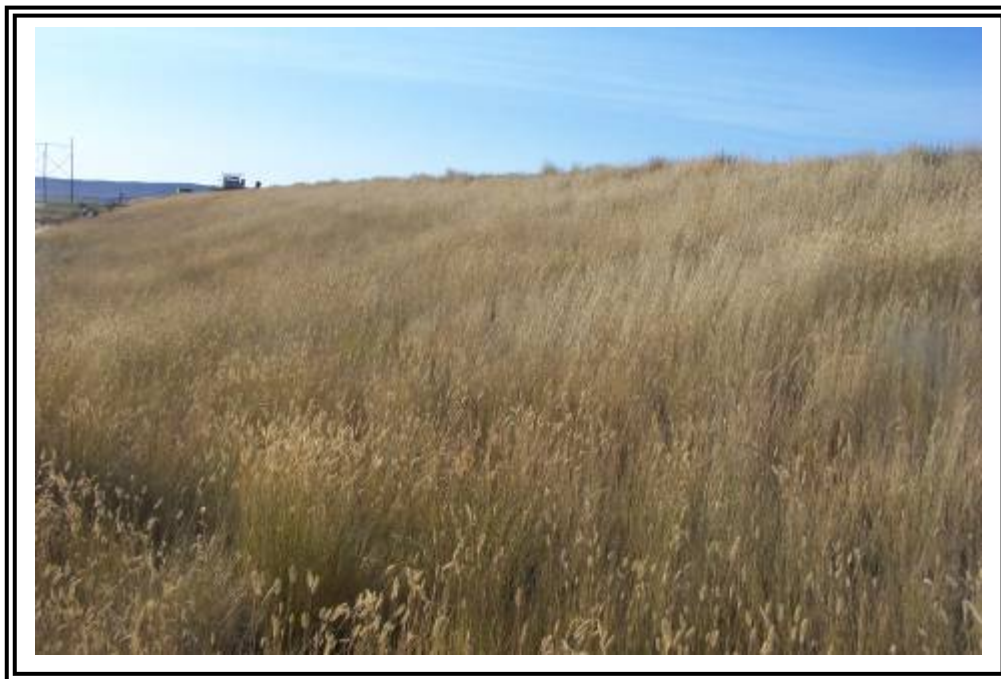
94

Typical vegetation cover on northeast dike downstream slope (crescent wheat).

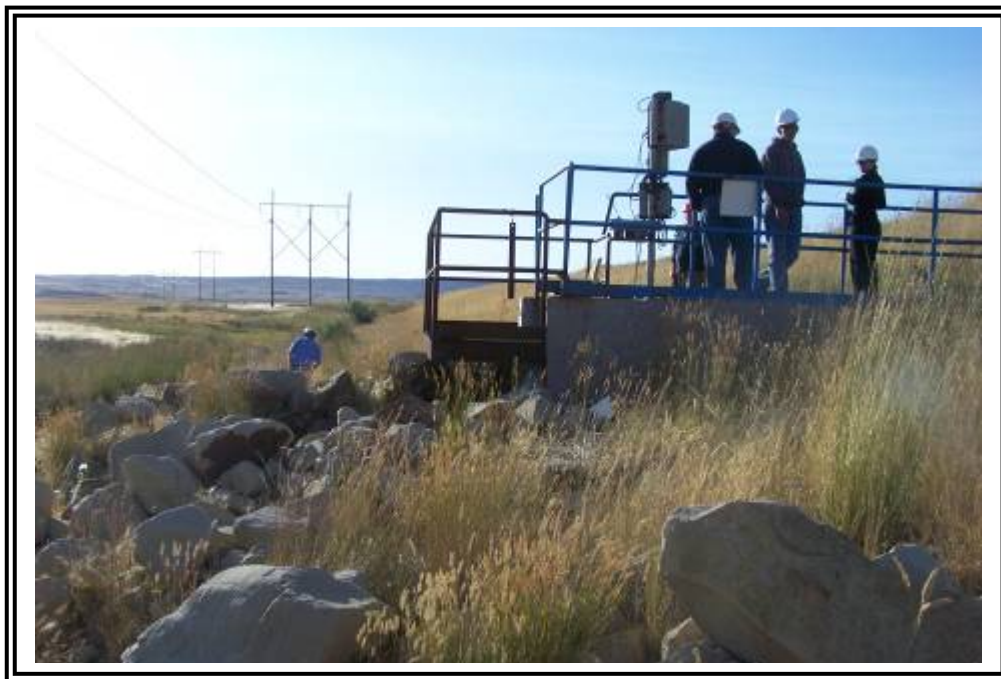
96

Downstream end of outlet control structure on northeast dike.

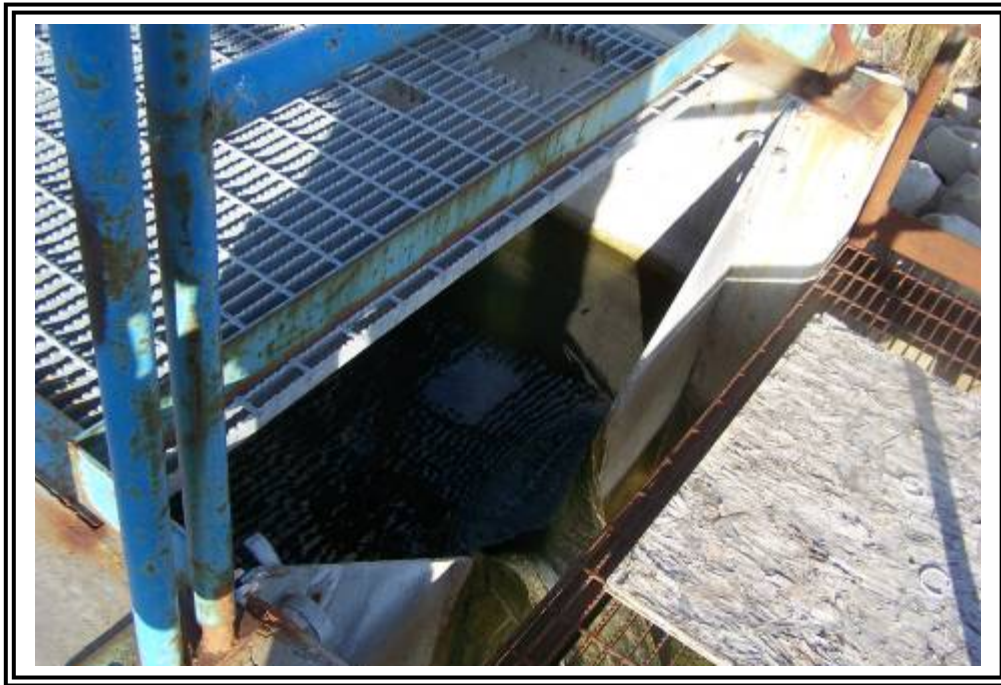
97

Outflow from control structure.

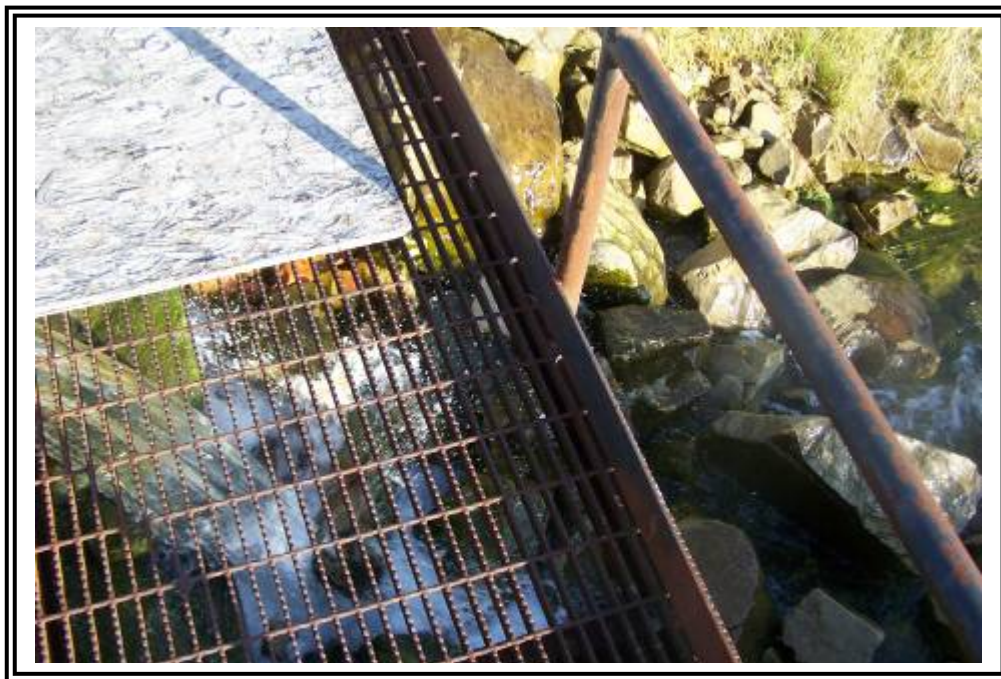
98

Outflow from control structure.

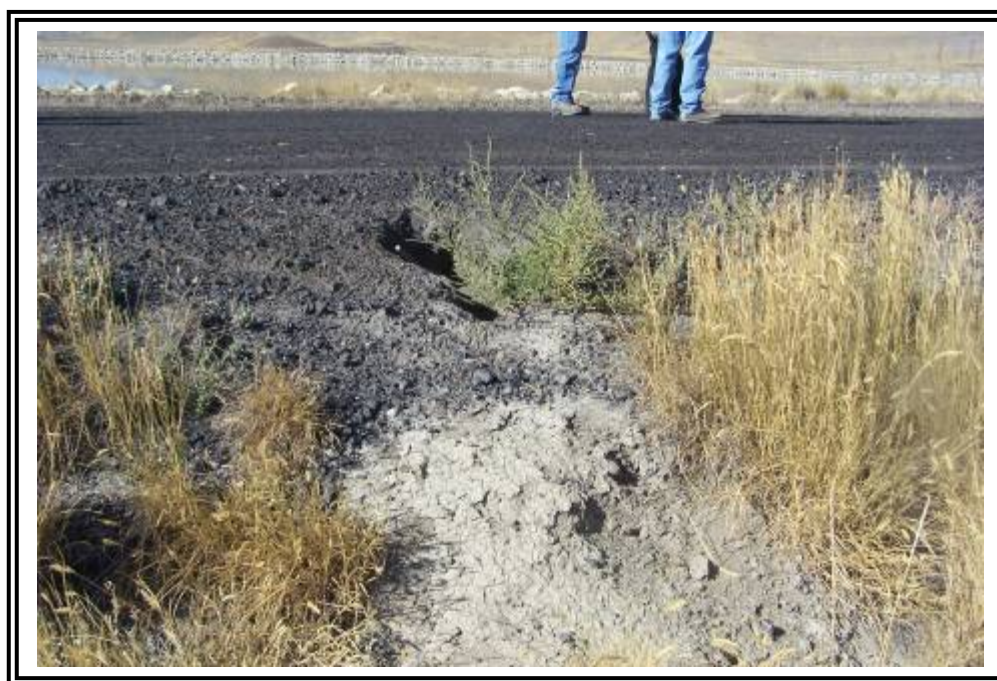
104

Animal burrow on east dike.

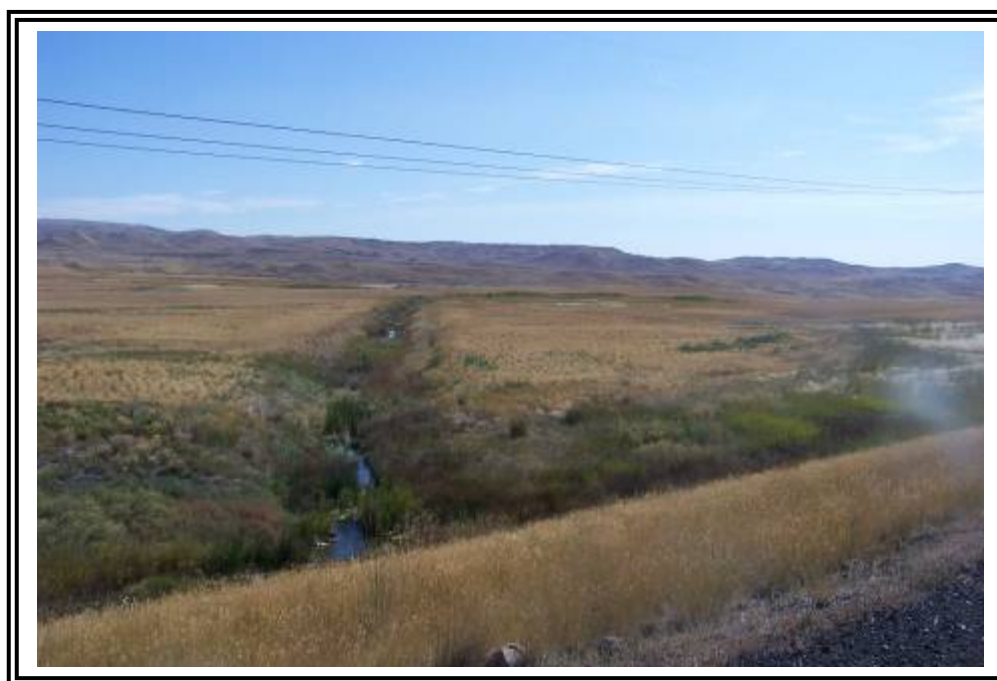
106

Discharge channel diverts away from northeast dike. Possible seepage to southeast (right in photo) of diversion point.

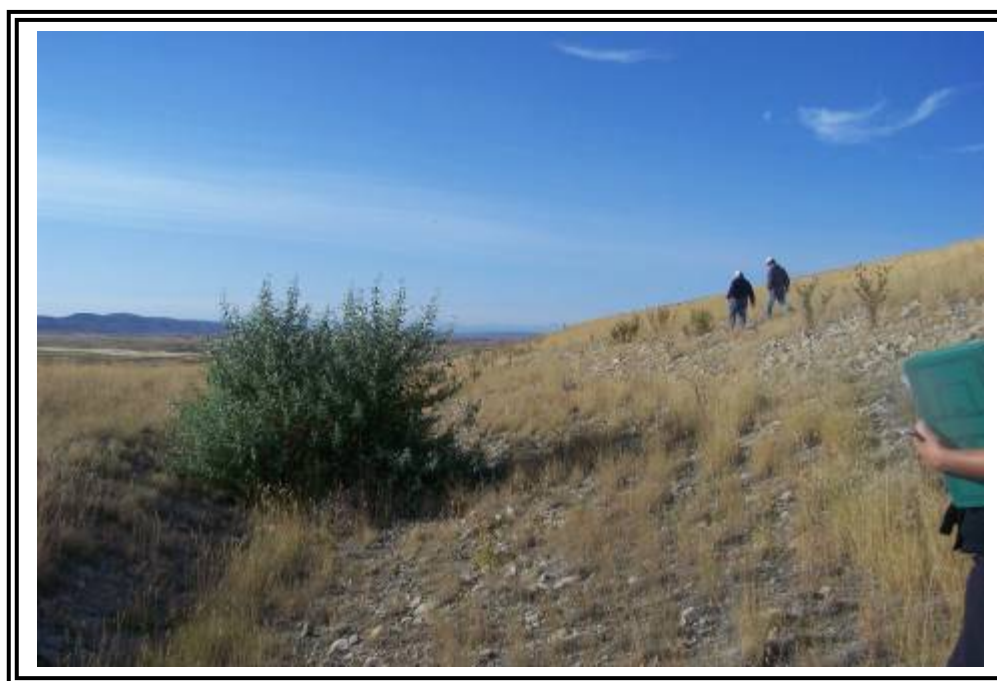
108

Sage bush at toe of east dike. Gravel along lower portion of slope associated with toe drain (looking south).

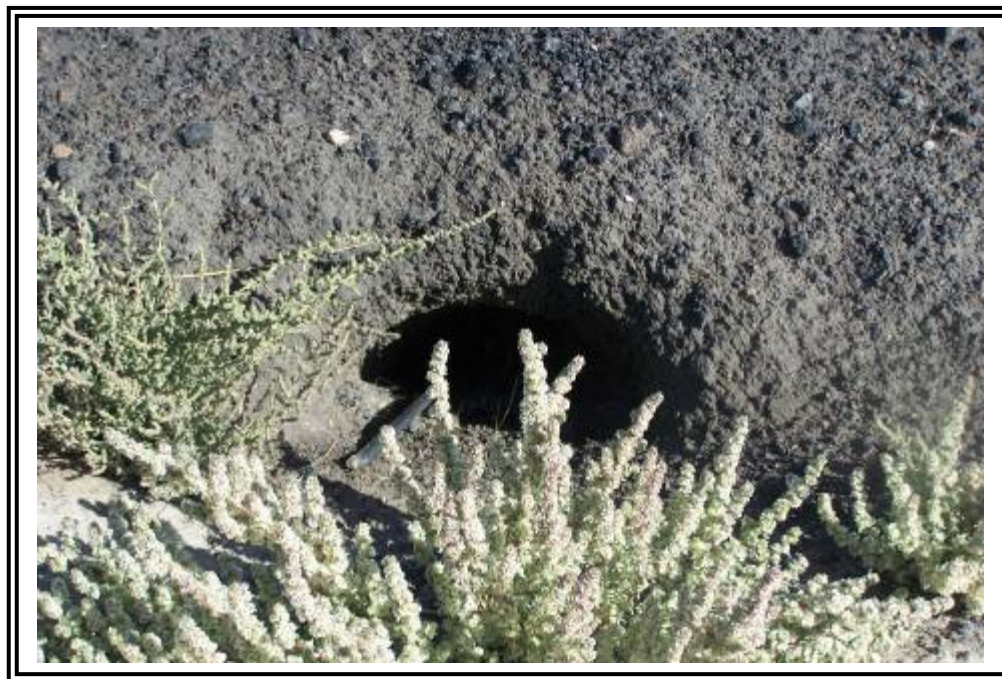
112

Close up of animal burrow on East Dike, 2 foot rebar sticking out about 6-8 inches.

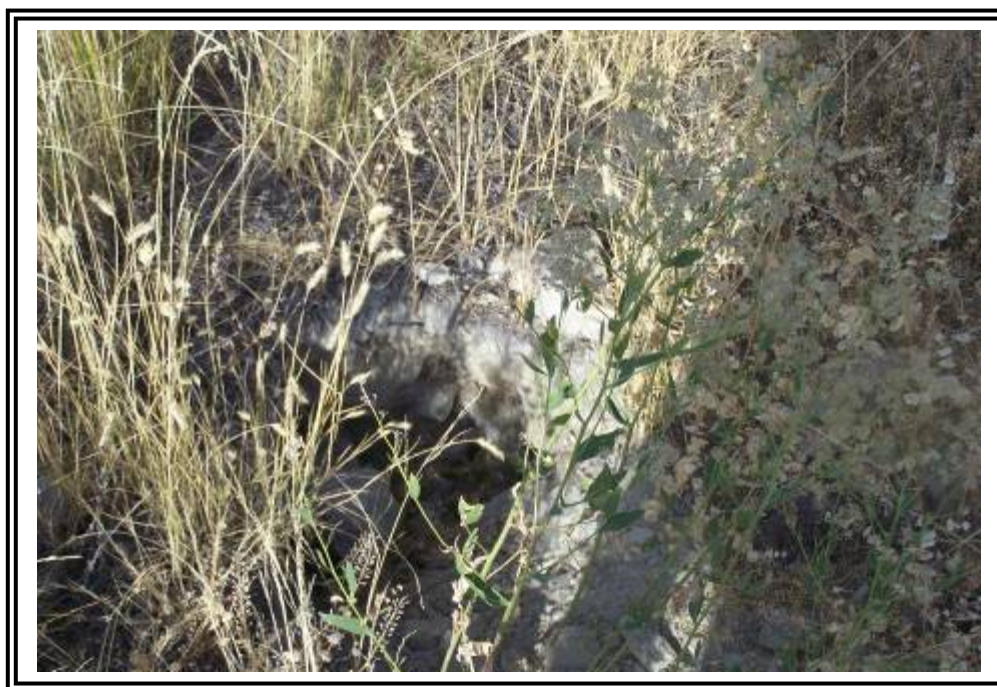
117

Close up of animal burrow.

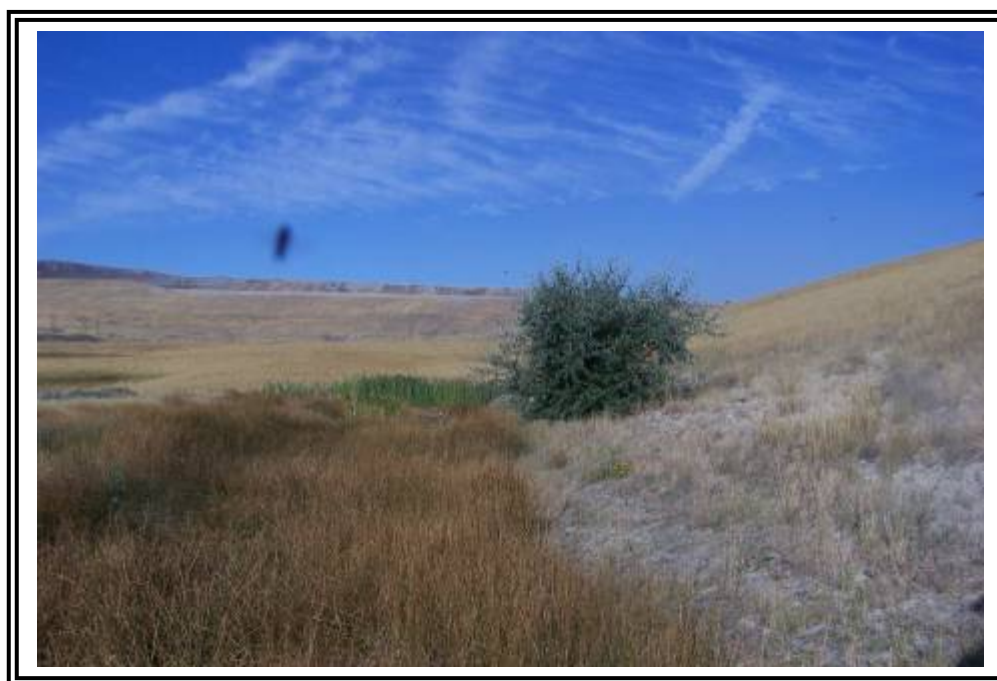
118

Seepage at South Dike toe, sage bush, looking west.

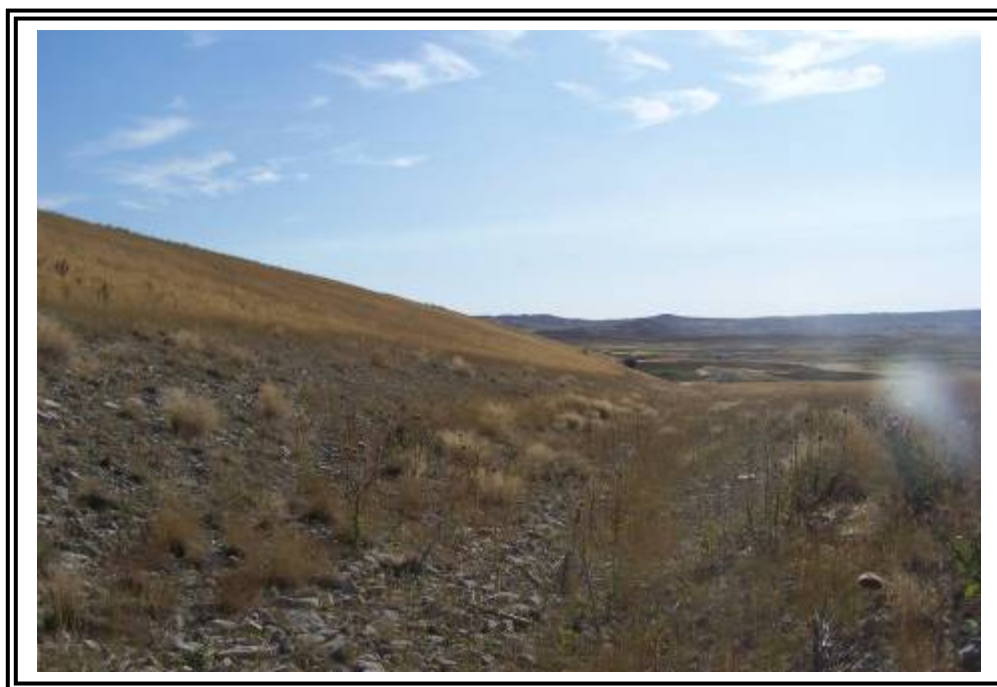
119

South Dike looking east. Rip rap associated with toe drain.

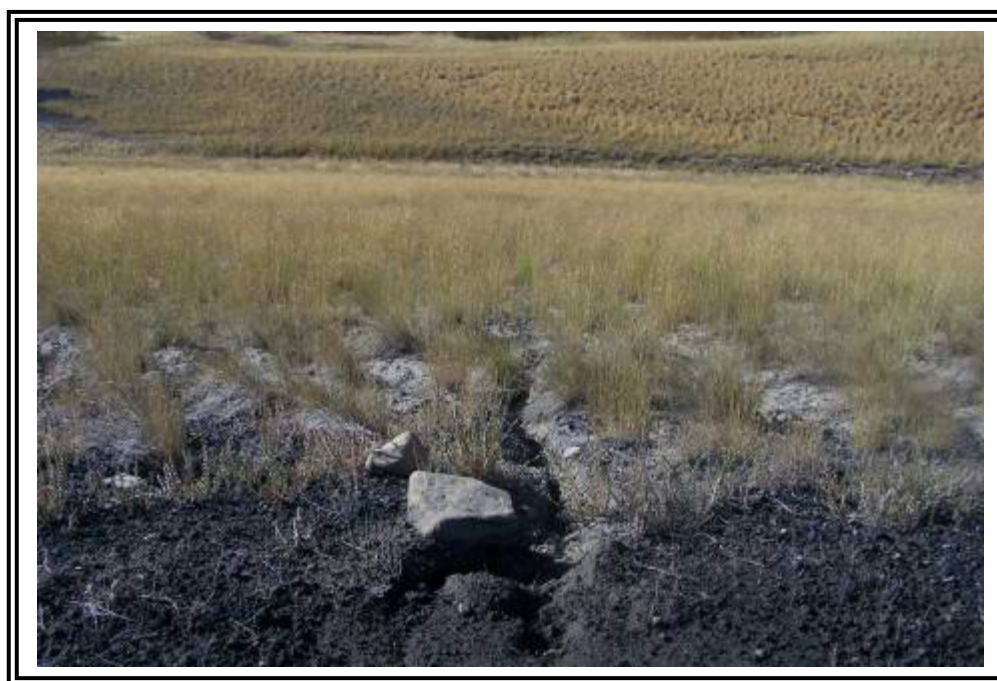
124

Occasional erosion rills along crest/downstream slope contact on South Dike.

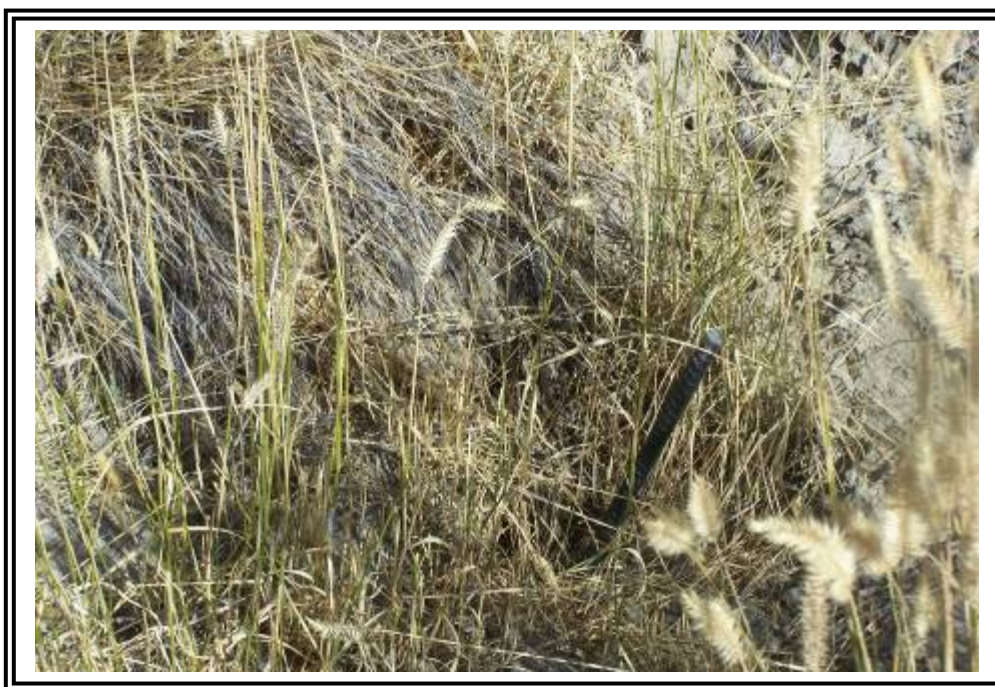
125

Animal burrow obscured by vegetation.

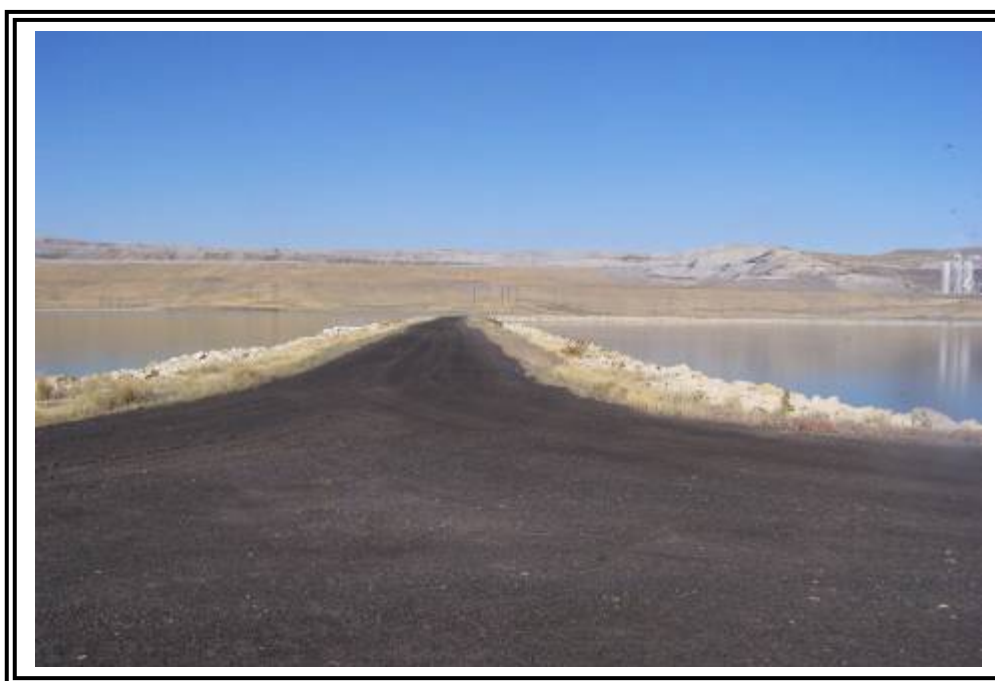
126

Crest of Intermediate Dike, looking west. Upstream and downstream faces covered with large rip rap.
Primary pond to the left, clear water pond to the right.

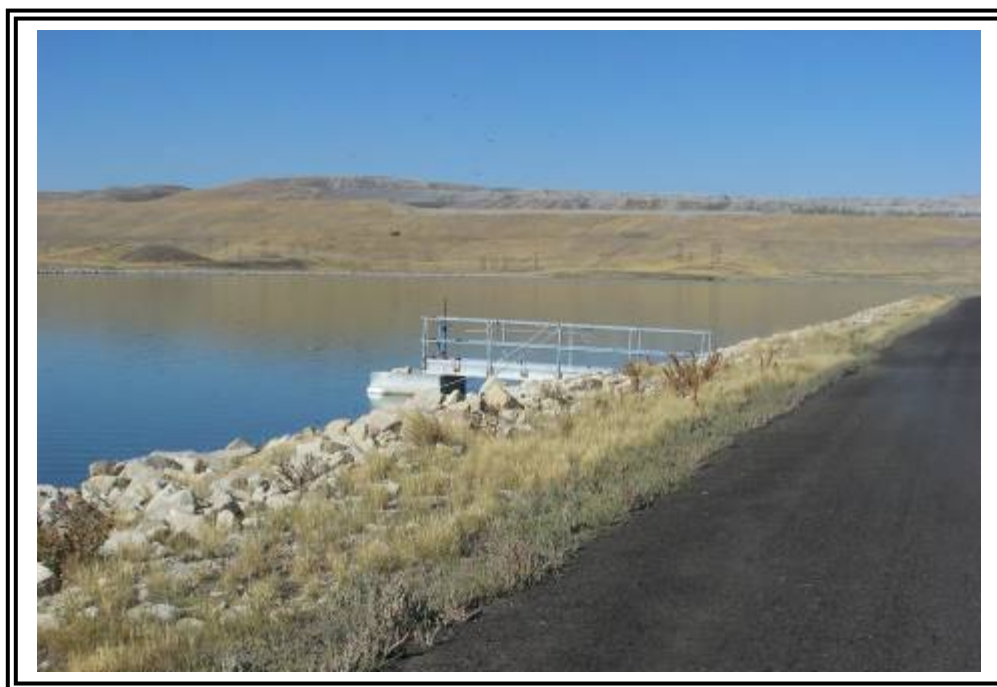
127

Decant structure in primary pond.

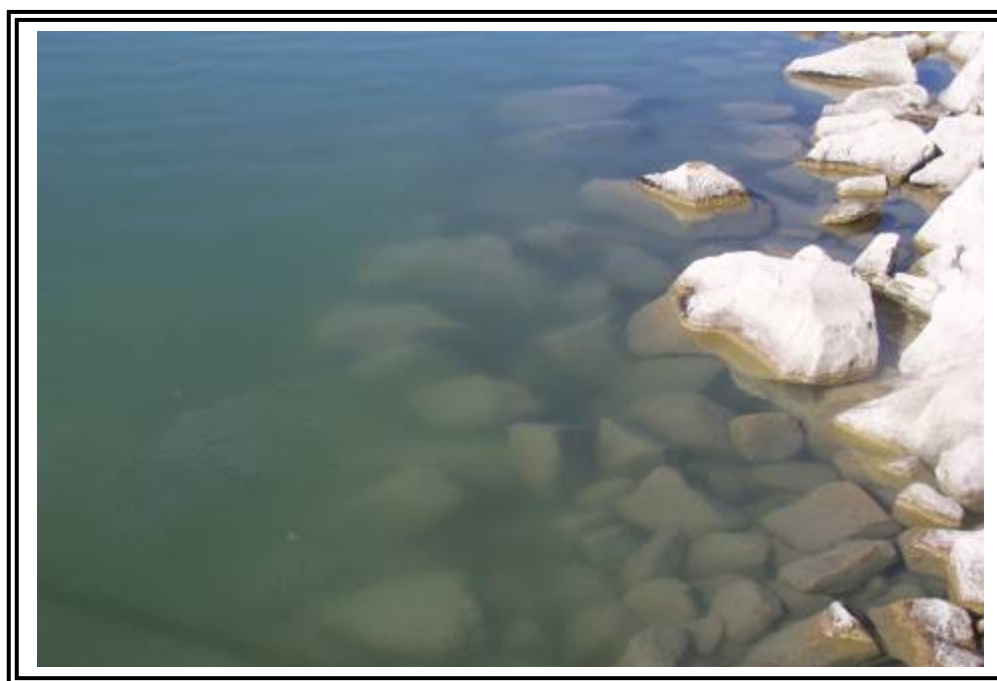
128

Typical rip rap on submerged slope extends below the water level.

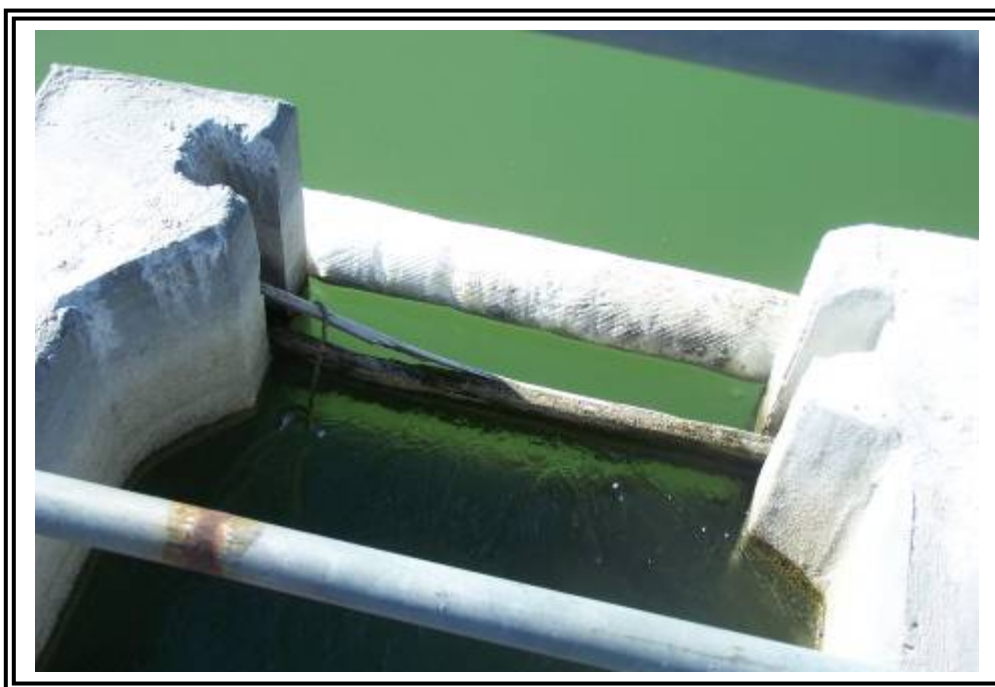
129

Intake.

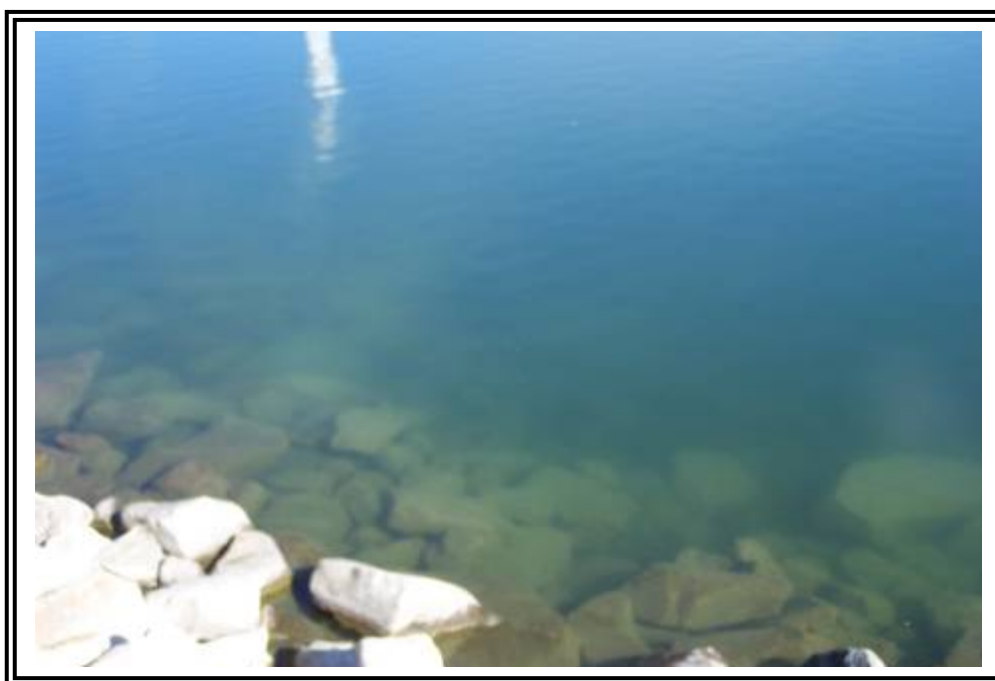
130

Area of discharge into clear water pond submerged and surrounded by rip rap.

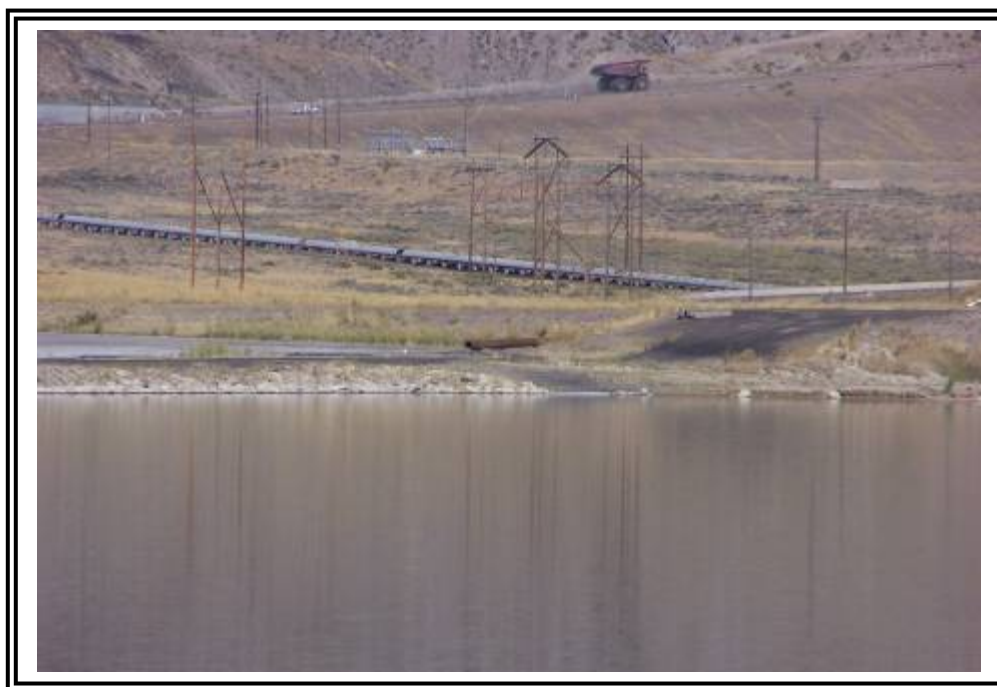
131

Sluice discharge into north side of South Ash Pond.
